Re: Restoration of Reach 1, of Dicks Creek, Monroe Ditch, and Outfall 002, Operation and Maintenance Plan, AK Steel Corporation, Middletown, Ohio; Revision 1, January 2014

Dicks Creek Reach 1 and Monroe Ditch – Recommended Changes to O&M Plan Outline
O&M Plan Revision 1, January 2014

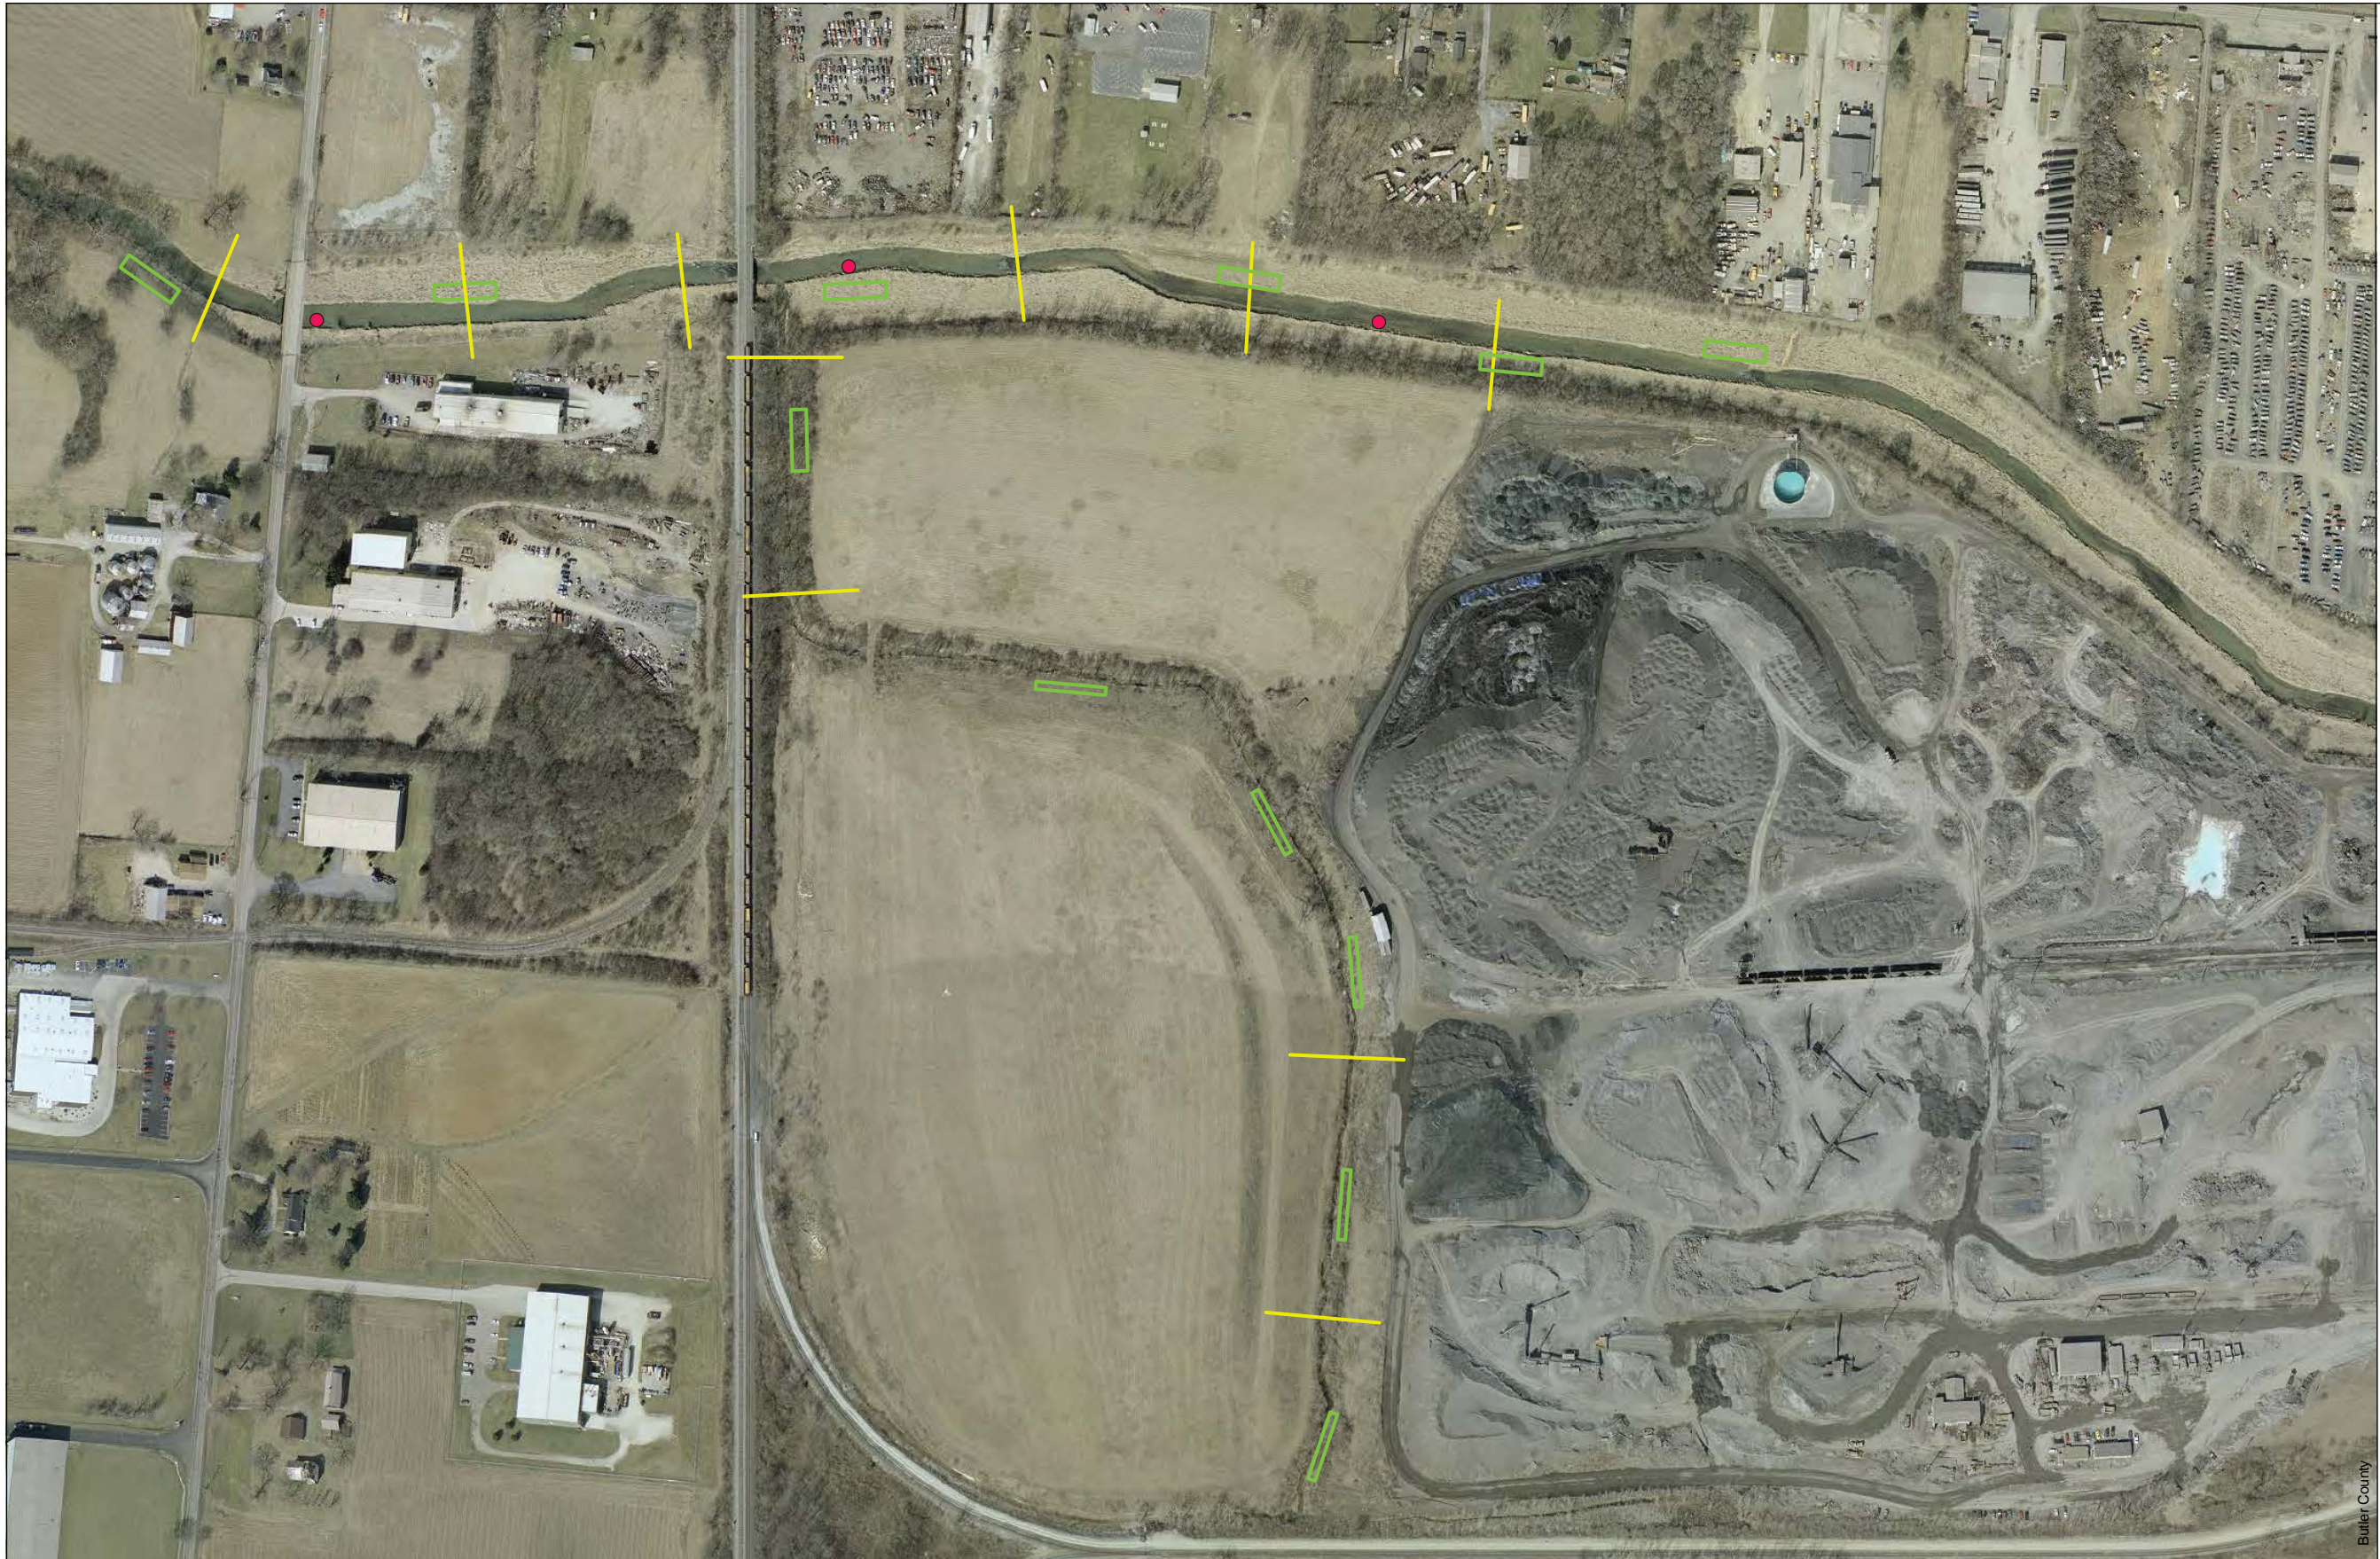
- FQAI Areas
- QHEI Locations 1987-2000
- Proposed QHEI Zones
